CANADIAN FORCES FLIGHT SAFETY INVESTIGATION REPORT

FINAL REPORT

FILE NUMBER: 1010-C-GVWT
DATE OF REPORT: 11 Oct 2001

AIRCRAFT TYPE: C-172M
DATE/TIME: 26 July 2000 1250 Z
LOCATION: Bromont Quebec
CATEGORY: B Category Air Accident

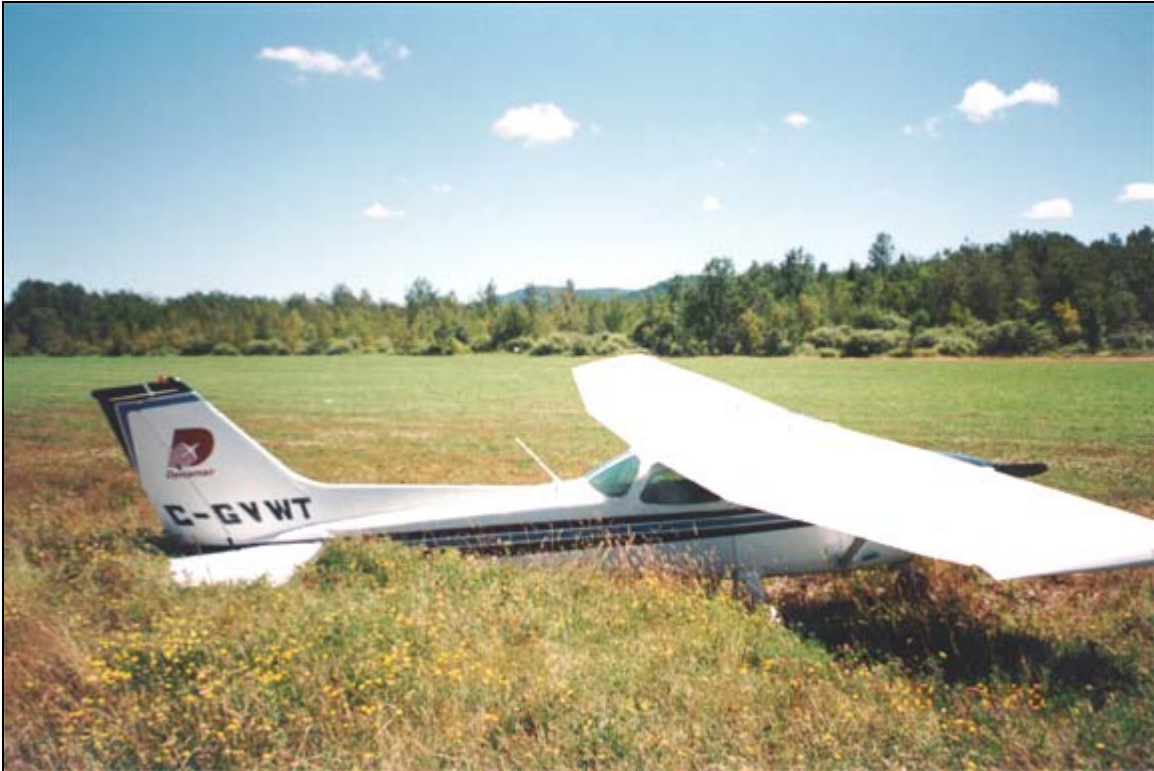
The crash was survivable. The aircraft retained enough velocity to cross over the first ditch with little damage, and had lost enough velocity by the time it reached the second ditch that the impact force was considerably reduced.

Photo 1: Final Resting Place (Aircraft in second ditch, tail on ground)

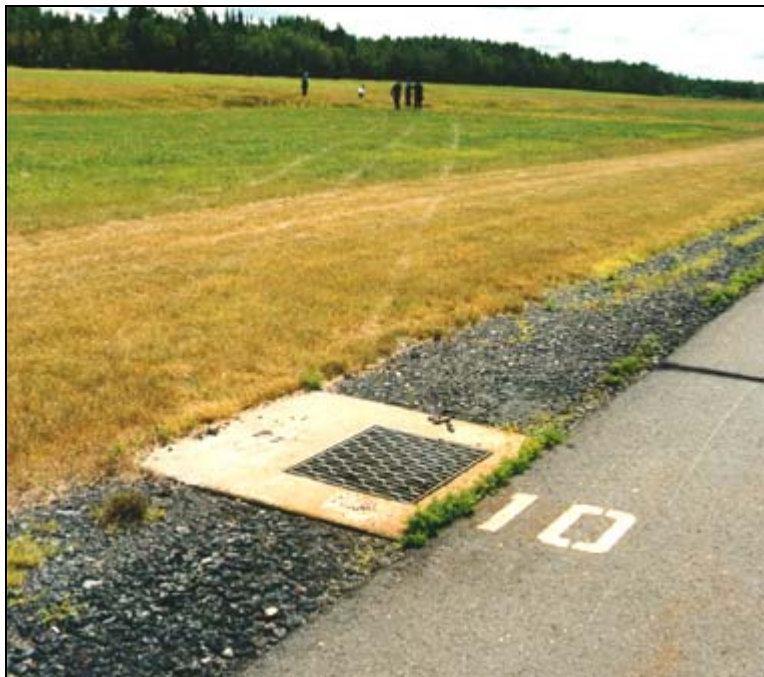
Photo 2: Aircraft tracks in grass (aircraft removed, personnel at first ditch)

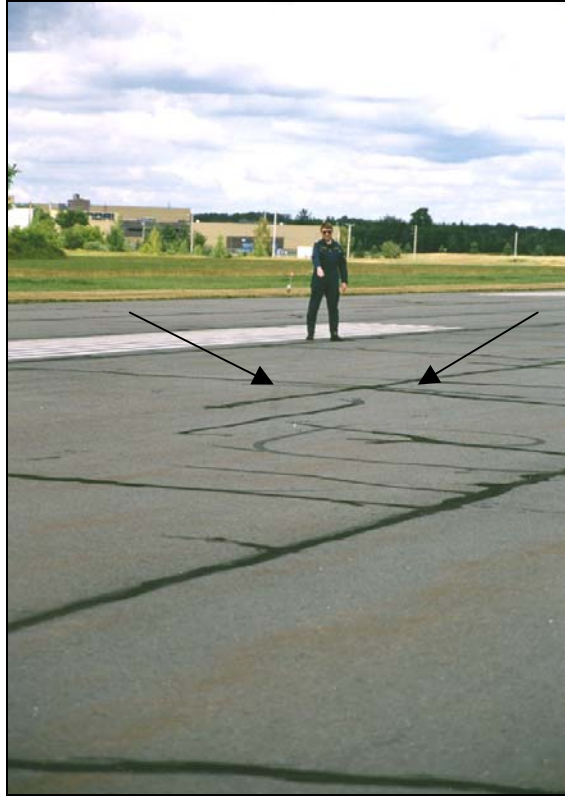
The aircraft left visible tire imprints on the runway surface. The marks were too faint to be photographed in their entirety but were visible to the naked eye. Following these tire marks along the runway one could see that the aircraft landed on the runway centreline and tracked straight until the 1500 foot runway markings where it executed a sharp turn to the left and exited the paved surface. (see photos 2 and 3) There was no evidence on the runway indicating that the aircraft did any swerving or zigzags across the centreline. The lack of any skid marks indicated that at no time was the braking action sufficient to cause wheel lock-up. The tire marks also showed distinctly the thread pattern, indicating that the wheels were travelling along their plane of rotation (no sideways skidding). This evidence leads to the conclusion that there were no erratic lateral movements of the aircraft but rather a single event leading to the departure from the paved surface. This single event is most likely an improper reaction to the prevailing crosswind and/or to the torque caused by the application of full power.

3.1.4 Tire marks on the runway indicated that the aircraft travelled in a straight line until it made a sharp turn to the left and exited the runway.

Photo 3: Tire marks on runway

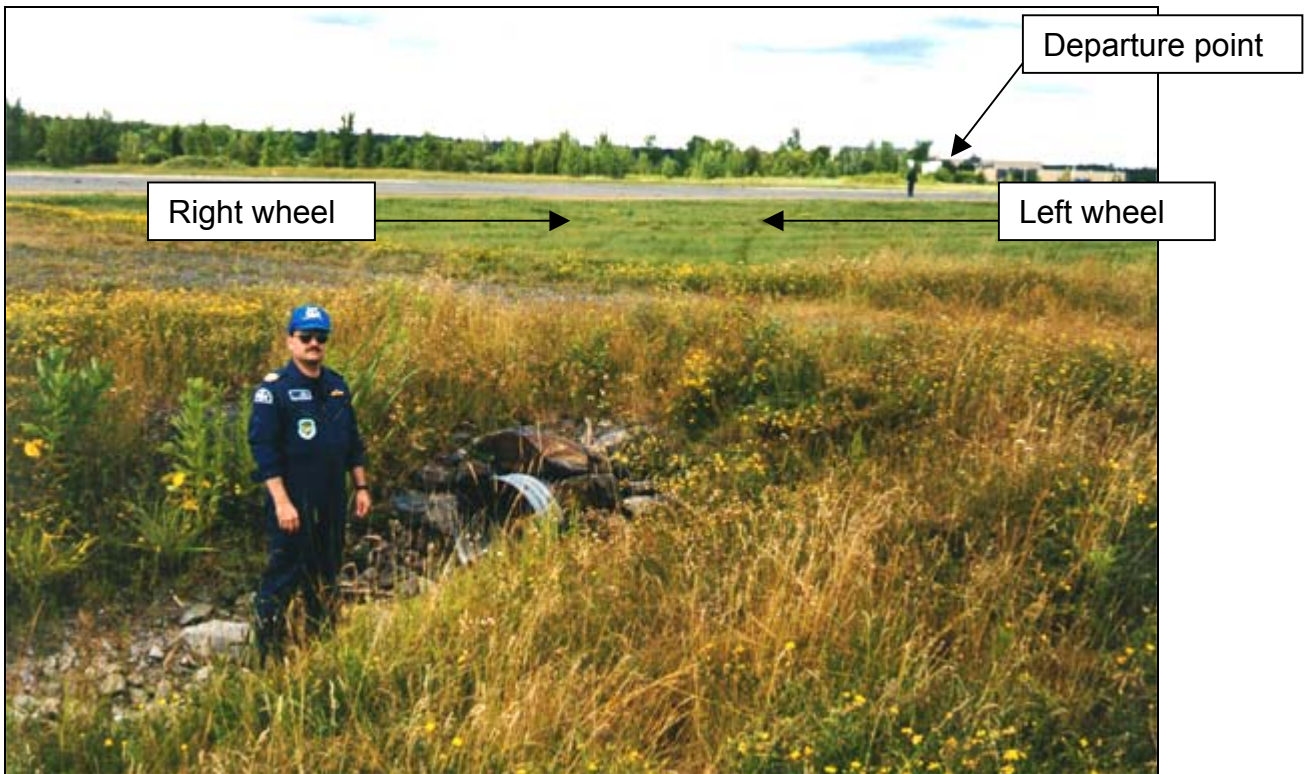
The aircraft travelled 500 Ft through the unprepared area to the left of the runway before coming to rest in a shallow ditch. Halfway through its "off road" travel, the aircraft crossed a four-foot ditch (photo 4) without dropping into it, indicating that the aircraft was still travelling with enough speed to sustain partial flight. A Cessna 172 traveling on an unprepared grass area at idle power would most likely have stopped before the four foot ditch or at worst would have slowed down sufficiently to be unable to cross this ditch. This evidence leads to the conclusion

that the power was not retarded prior to leaving the paved surface, as stated by the student, but most likely closer to the first ditch, indicating that he was still attempting to take-off when he left the runway or that he was “shocked” by what was happening.

3.1.5 The aircraft flew over the first ditch, indicating that the speed was still sufficient at this point to maintain partial flight.

Photo 4: First ditch

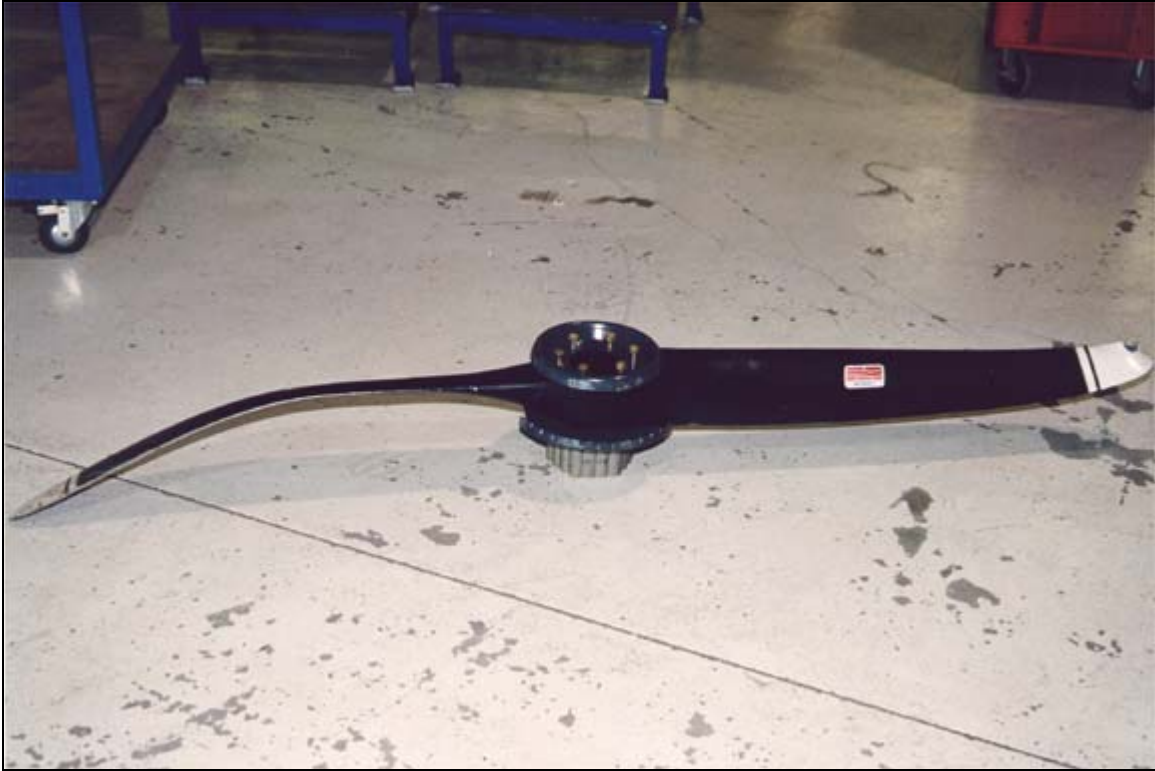
The aircraft received "B" Category damage. The propeller was dented and bent at the tips. The engine was pushed out of alignment and was sent to overhaul. The left wing tip struck the ground and was heavily damaged. The nose gear was bent out of alignment. There was extensive rippling of the aircraft's skin in numerous locations, mostly centred around the mid fuselage and the base of the empennage, and some structural bulkheads were deformed. The fibreglass fairing around the base of the rudder was cracked, and seals around the rear windows were loosened.

Photo 5: Damaged propeller
